**Confidential Inspection Report**  
**321 Oak St**  
**Chicago, IL 60617**

June 8, 2012

RE: 321 Oak St  
Chicago, IL 60617

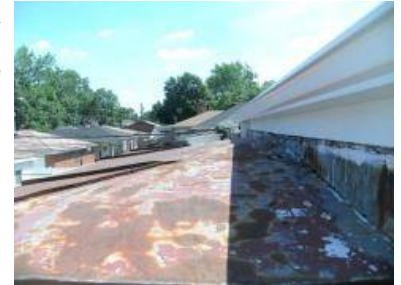
**Unsatisfactory** The small bump out at the back is a tin roof it is in a poor condition it is rusty and poorly fastened. Recommend to have a roofer evaluate this and install new roofing materials.

**Unsatisfactory** The small bump out at the back is a tin roof it is in a poor condition it is rusty and poorly fastened. Recommend to have a roofer evaluate this and install new roofing materials.

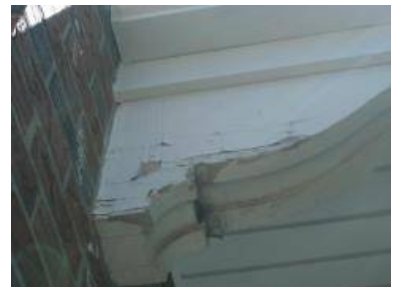
**Marginal** The wood trim at the front porch has peeling paint. Painting is needed there.

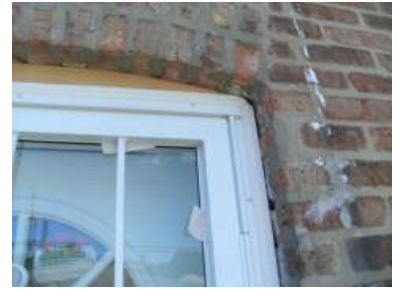
**Marginal** The rear exterior door trim needs to be caulked to the brick. The top piece of trim there also needs to be painted.

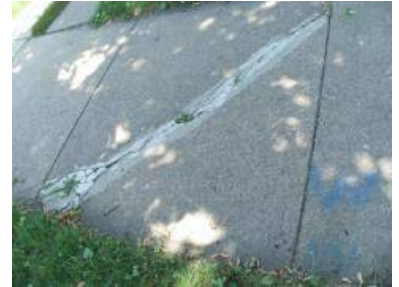
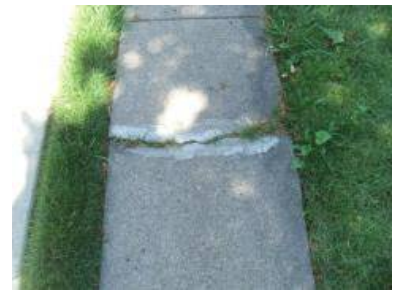
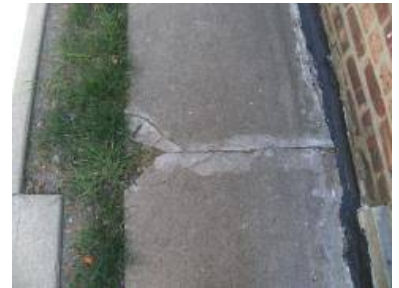
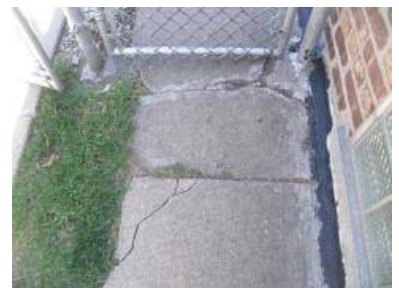
**Unsatisfactory** In the front and side and backyard there is some major cracks and offsets on the walkway. Recommend to repair the damaged sections.

**Unsatisfactory** In the front and side and backyard there is some major cracks and offsets on the walkway. Recommend to repair the damaged sections.

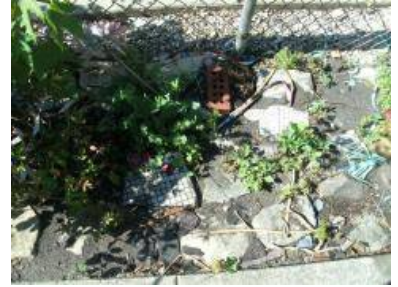
**Unsatisfactory** There is a lot of construction debris that needs to be cleaned up on the grounds.

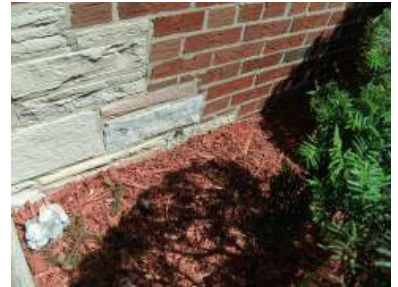
**Unsatisfactory.** The grading is too high on some spots. It should always be below the foundation otherwise the basement has a higher chance of getting seepage. This is in the front of the house they built up the ground there. Recommend that this gets repaired.

**Unsatisfactory.** The grading is too high on some spots. It should always be below the foundation otherwise the basement has a higher chance of getting seepage. This is in the front of the house they built up the ground there. Recommend that this gets repaired.

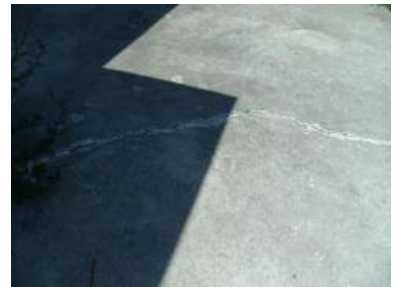
**Marginal,** Cracks noted are moderate. Repair needed.

**Marginal,** Cracks noted are moderate. Repair needed.

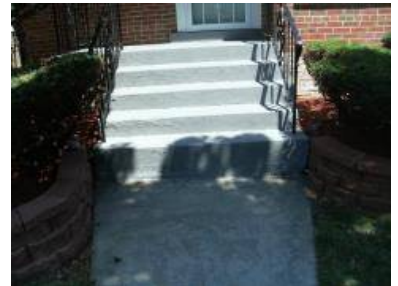
**Unsatisfactory.** Improper rise/run on steps. This is a potential safety hazard. Recommend repair or replacement. The first step is way too high this is a safety hazard. Repair is needed for safety. You may be able to have the walkway in front of this raised by a contractor to repair this.

**Unsatisfactory.** Improper rise/run on steps. This is a potential safety hazard. Recommend repair or replacement. The first step is way to high this is a safety hazard. Repair is needed for safety. You may be able to have the walkway in front of this raised by a contractor to repair this.

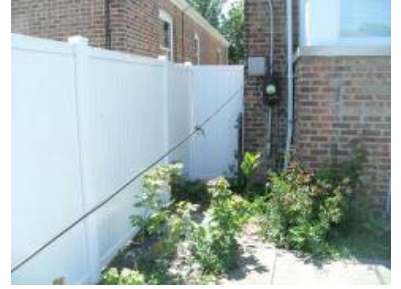
There is a tree stump in the back yard. Recommend to have it removed because it can potentially attract wood destroying insects. There is what looks to be a cable line that is hanging down. Needs to be installed properly. Recommend to contact the cable company about this.

There is a tree stump in the back yard. Recommend to have it removed because it can potentially attract wood destroying insects. There is what looks to be a cable line that is hanging down. Needs to be installed properly. Recommend to contact the cable company about this.

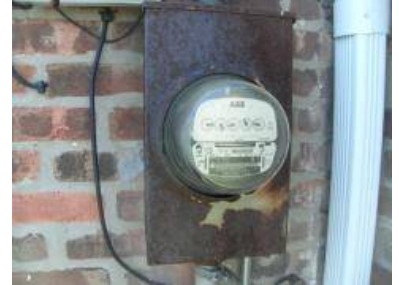
Overhead, 120/240 Volt, **Marginal**, Circuit breakers, 100 Amp Service. The electrical meter box is extremely rusty. Recommend to have the electric company evaluate this to see if replacement of this is needed.

Overhead, 120/240 Volt, **Marginal**, Circuit breakers, 100 Amp Service. The electrical meter box is extremely rusty. Recommend to have the electric company evaluate this to see if replacement of this is needed.

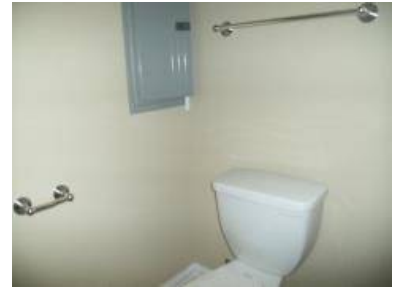
**Unsatisfactory**. Basement bathroom. The electrical panel is in a very poor location right near a toilet. The required amount of space in front of a electrical panel is 3 feet there is now only about 1 feet. This is a safety hazard Highly recommend to have a electrician evaluate this and have the panel moved to the proper location or safety. This is a expensive repair.

**Unsatisfactory.** Basement bathroom. The electrical panel is in a very poor location right near a toilet. The required amount of space in front of a electrical panel is 3 feet there is now only about 1 feet. This is a safety hazard Highly recommend to have a electrician evaluate this and have the panel moved to the proper location or safety. This is a expensive repair.

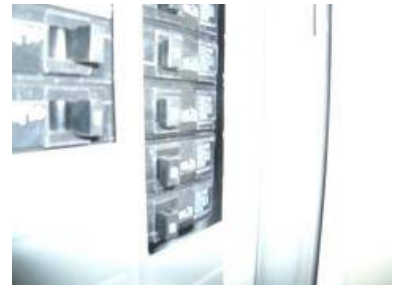
**Marginal**, Circuit and wire sizing correct so far as visible, Grounding system is present The cover on the panel is not tight to the breakers, there is a gap there. This is a safety hazard. Repair is needed or safety. This is besides the panel needing to moved to the proper location or safety reasons.

**Marginal**, Circuit and wire sizing correct so far as visible, Grounding system is present The cover on the panel is not tight to the breakers, there is a gap there. This is a safety hazard. Repair is needed or safety. This is besides the panel needing to moved to the proper location or safety reasons.

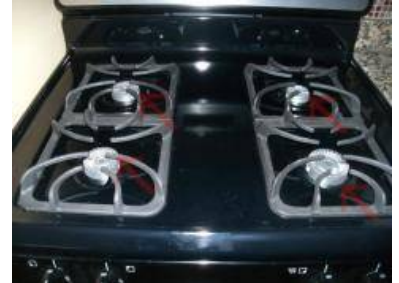
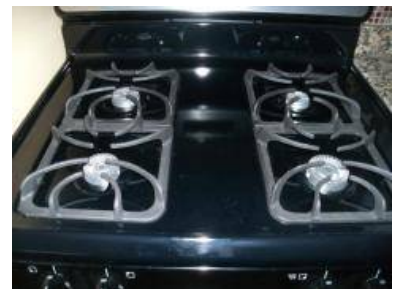
**Unsatisfactory.** Gas, Range. The gas range burners are not automatically lighting. It appears that the caps for the top of the burners are missing causing this to not ignite. The proper caps need to be installed.

**Unsatisfactory.** Gas, Range. The gas range burners are not automatically lighting. It appears that the caps for the top of the burners are missing causing this to not ignite. The proper caps need to be installed.

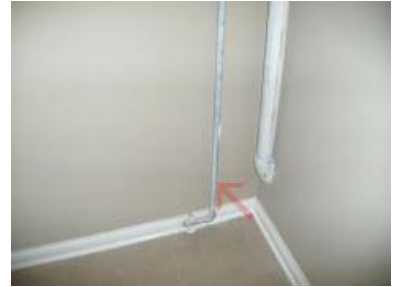
*CONDITION:* **Marginal**, Electrical outlet is grounded, Gas service pipe is provided. The gas pipe for the dryer is not properly fastened. Additional fasteners are needed.

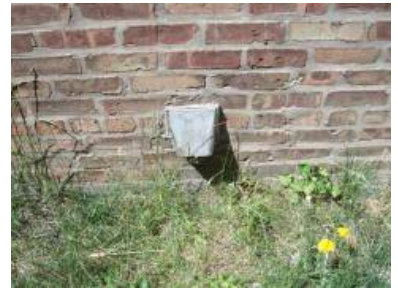
*Dryer Ventilation:* **Unsatisfactory** The flap on the dryer vent cover no longer closes. A new dryer vent cover should be installed.

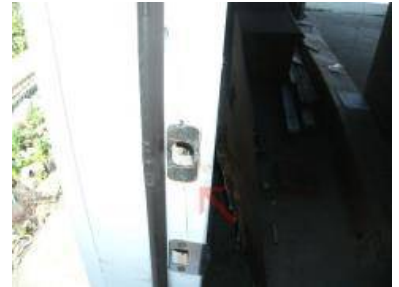
**Unsatisfactory** The door jamb is split at the door catches. This needs repairs or security reasons.

**Unsatisfactory** The door jamb is split at the door catches. This needs repairs or security reasons.

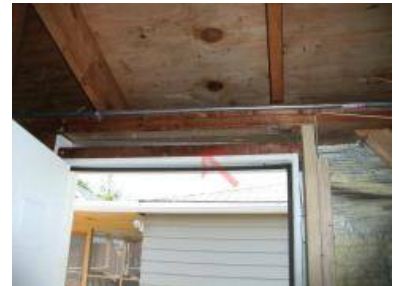
Unfinished. **Marginal** There is no header above the service door like there should be. Recommend that a carpenter installs a header there or support.

Unfinished. **Marginal** There is no header above the service door like there should be. Recommend that a carpenter installs a header there or support.

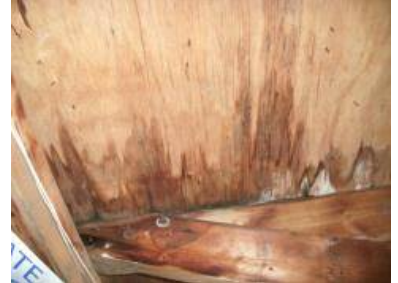
**Unsatisfactory**. Conventional framing. There is a quite bit of roof sheathing that has water stain and this has caused some of the sheathing to get rotted. Some has been replaced. More should have been replaced. Repair is needed.

**Unsatisfactory**, Conventional framing. There is a quite bit of roof sheathing that has water stain and this has caused some o the sheathing to get rotted. Some has been repalced. More should have been repalced. Repair is needed.

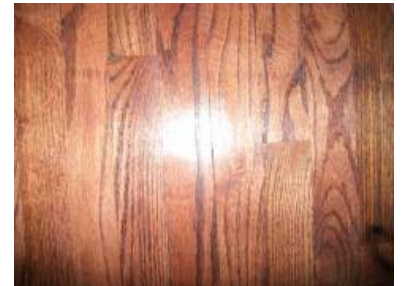
*TYPE & CONDITION:* Combination of Wood, Tile, Marginal. The wood floors were poorly sanded and poorly finished. Recommend that they get refinished.

Combination of Wood, Tile, **Marginal**. The wood floors were poorly sanded and poorly finished. Recommend that they get refinished.

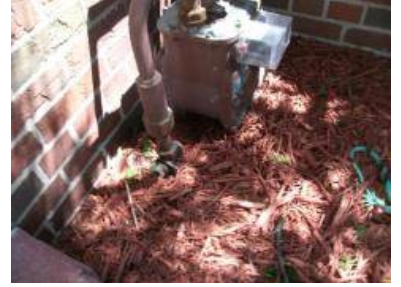
**Marginal** The mulch is in contact with the bottom of the gas meter. Recommend that the mulch get lower there so that it is no longer in contact with the gas meter.

**Marginal** The mulch is in contact with the bottom of the gas meter. Recommend that the mulch get lower there so that i8t is no loger in contact with the gas meter.

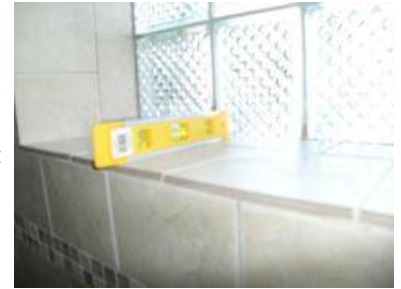
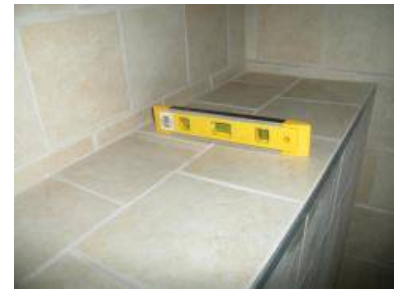
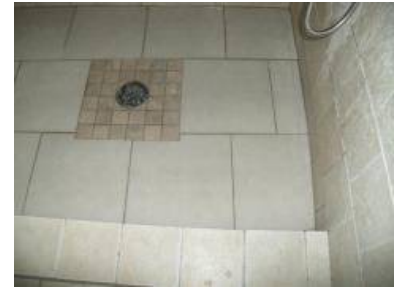
<i>BATH LOCATION:</i>	Basement.
<i>CONDITION OF SINK:</i>	Satisfactory. Faucet and drain appears serviceable.
<i>VANITY/PEDESTAL SINK</i>	Satisfactory.
<i>CONDITION OF TOILET:</i>	Satisfactory.
<i>SHOWER PLUMBING FIXTURES:</i>	<b>Unsatisfactory</b> There is a slow water leak coming from the shower head box. Repair is needed.
<i>RECEPTACLES:</i>	Satisfactory - A functional Ground Fault Circuit Interrupt outlet is installed in the bathroom.
<i>LIGHT FIXTURES:</i>	Satisfactory.
<i>SHOWER AREA:</i>	<b>Unsatisfactory</b> There is some very major issues with shower area. Such as the seat is pitched the wrong way. The window sill is pitched the wrong way. The tile base is also pitched the wrong way. There is a lot of water ponding on the shower tile base. These are all need to be repaired otherwise it is very likley that you will have water issues along with damage. This is a expensive repair. It is likley that the shower will need to be completely redone. Recommend to have a contractor out to give you a estimate before closing. A shower door or curtain also needs to be installed.

**Unsatisfactory** There is some very major issues with shower area. Such as the seat is pitched the wrong way. The window sill is pitched the wrong way. The tile base is also pitched the wrong way. There is a lot of water ponding on the shower tile base. These are all need to be repaired otherwise it is very likely that you will have water issues along with damage. This is a expensive repair. It is likely that the shower will need to be completely redone. Recommend to have a contractor out to give you a estimate before closing. A shower door or curtain also needs to be installed.

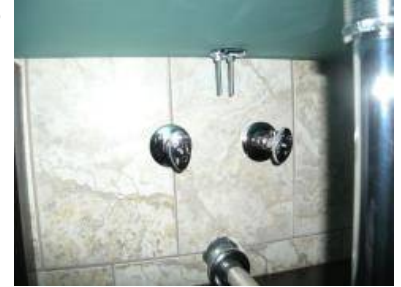
**Unsatisfactory** Water lines are not hooked up to the sink faucet. Repairs are needed by a plumber.

**Unsatisfactory** Water lines are not hooked up to the sink faucet. Repairs are needed by a plumber.
